# MONUMENT RECORD

Corner ID: **BeBI\_G11**

## Center Quarter Corner

Section 17- 10N-R02W, 2nd P.M.

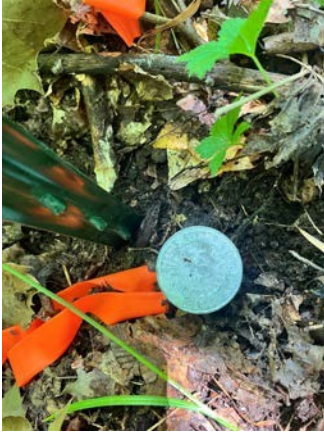
*Photo Orientation & Description:* From above

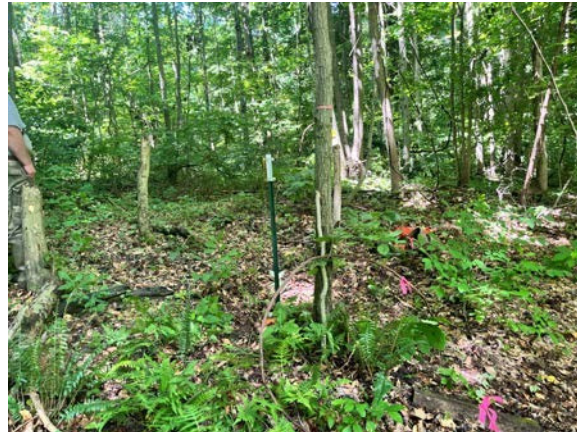
*Photo Orientation & Description:* From Northeast looking Southwest
